# New Additions to Historic Buildings

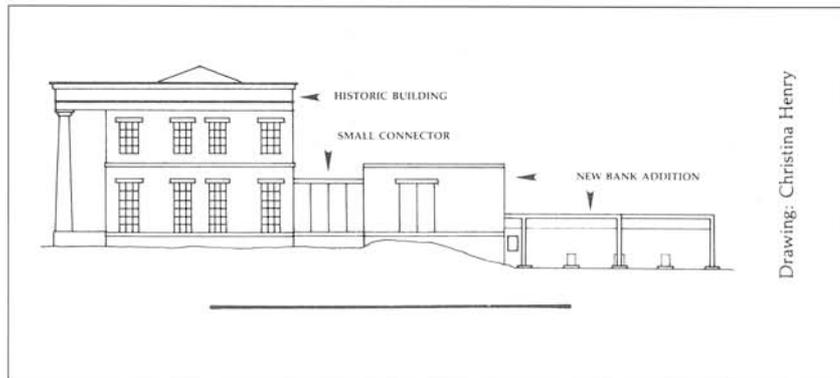
*An 1847 residence was successfully converted into a bank, with the construction of a low-scale addition. The drawing shows how the three-unit addition has been stepped down the hill, each unit set further back from the historic structure as it extends horizontally. As a result, the new addition is only partially visible from the historic "approach." The small connector was sensitively designed to minimize loss of historic building materials.*

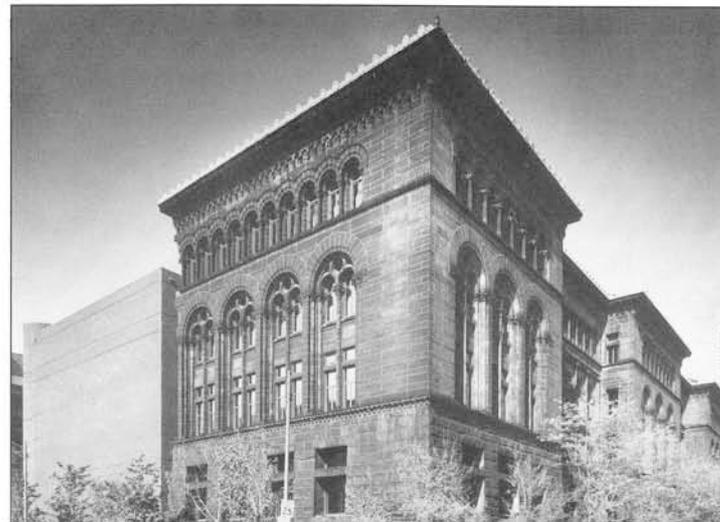
*A new 10-story wing added to the back of a historic library constitutes major expansion, yet is compatible because it reads as a subsidiary unit to the much larger historic building.*

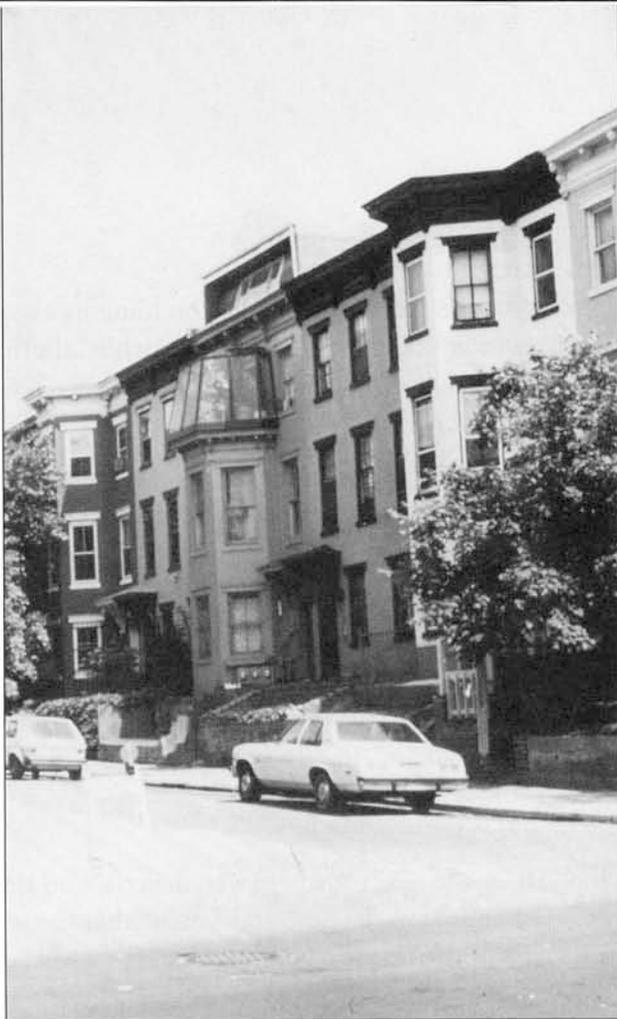
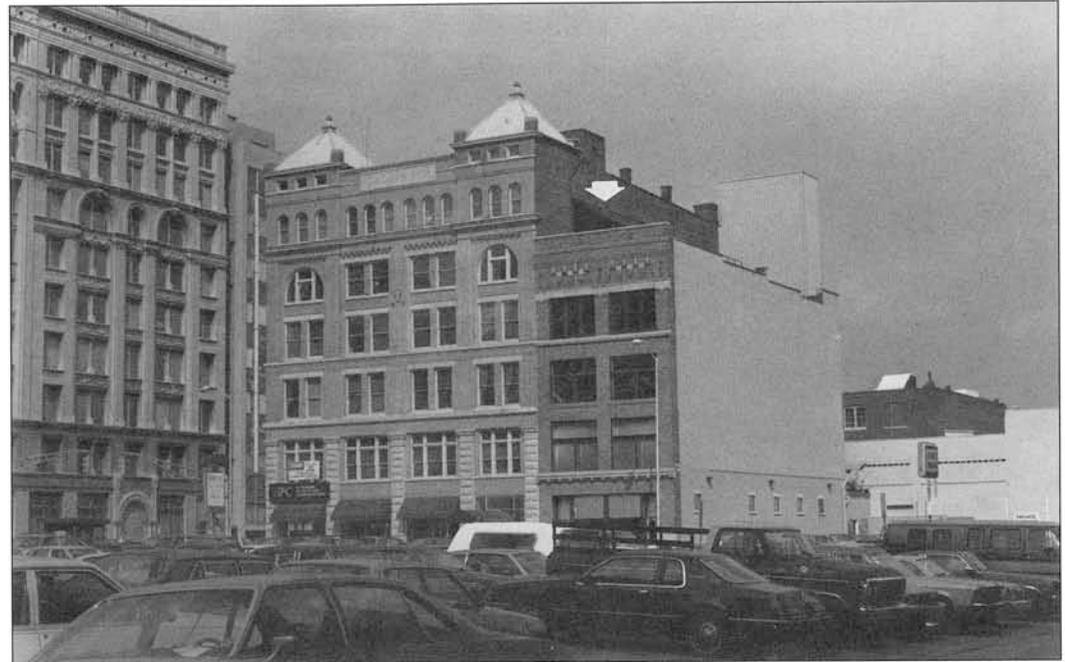
*Left: This rooftop addition has substantially altered the historic profile and proportions of a three-story row house; more important, it has interrupted the uniform roof height of the block. The greenhouse is also a jarring element in an otherwise intact 19th century streetscape. Below: A sizeable employee lounge was added atop this four-story historic commercial building. Because the rooftop addition has been set back from both the front and side roof edges against a party wall, the historic character of the building and the district have been preserved.*

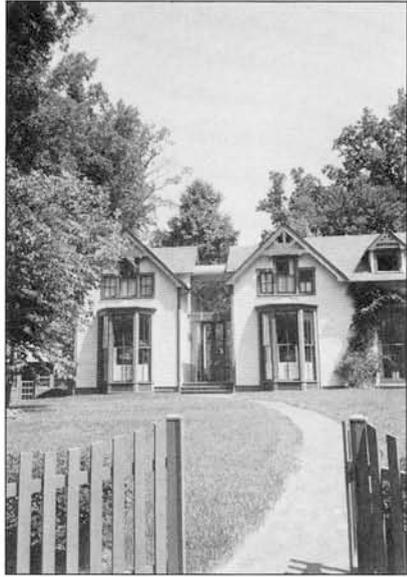
*The historic residence is on the right. By copying the decorative gable and three-part window in the new addition, the old and new portions are virtually indistinguishable. This approach violates the Standards for Rehabilitation.*

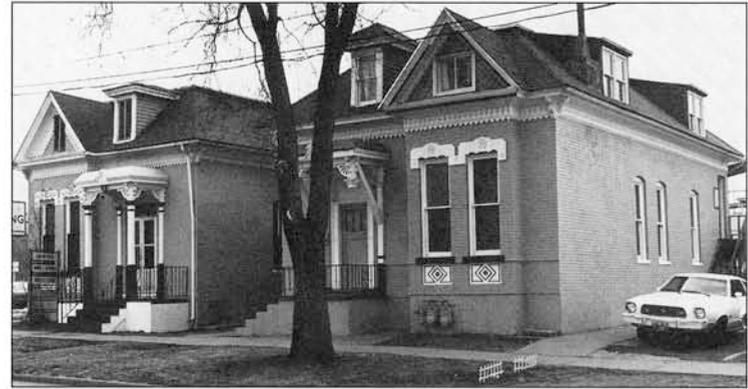
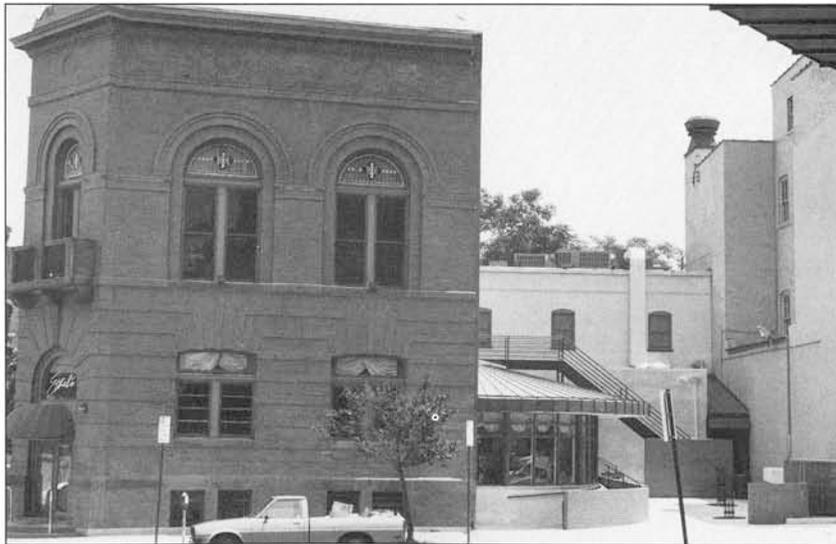
*In rehabilitating a historic bank for a new use, a small restaurant addition was built on the rear. The new addition is compatible with the historic building primarily because of its scale and location.*

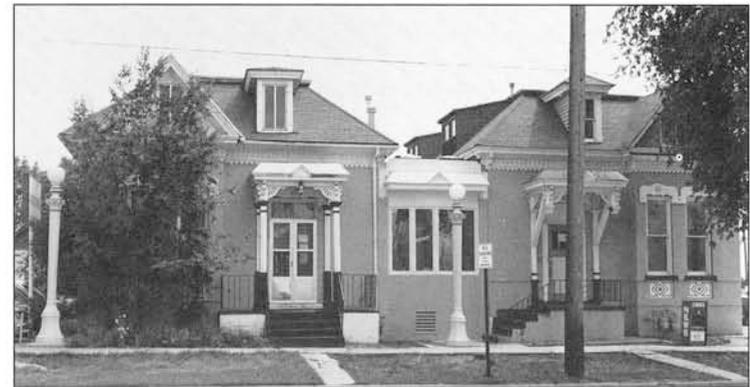
*Two small Victorian cottages, above, were connected to provide additional floor space in a commercial rehabilitation. The inappropriate infill connector, below, is on the same plane as the historic facades, essentially making the two cottages appear as one building. If the new infill had been substantially set back from the facade, the distinct form of each cottage would have been retained.*
